Curry Road Proposed Culvert - 100 Year Storm

Reynolds Road Existing Culvert - 100 Year Storm

APPENDIX E

EXISTING CULVERT PHOTOGRAPHS

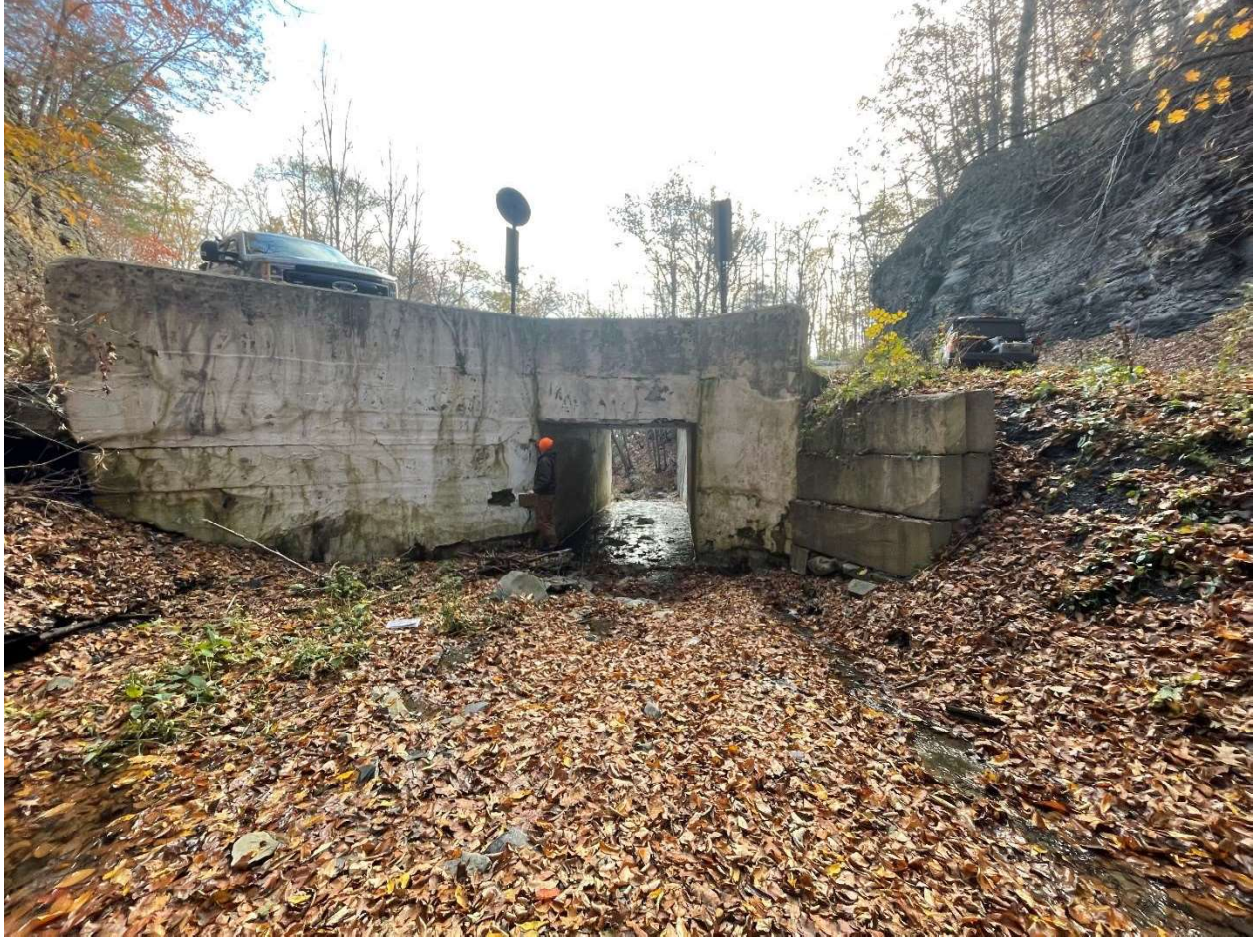
Figure 1. Maplewood Road culvert looking east. No embedment throughout the culvert.

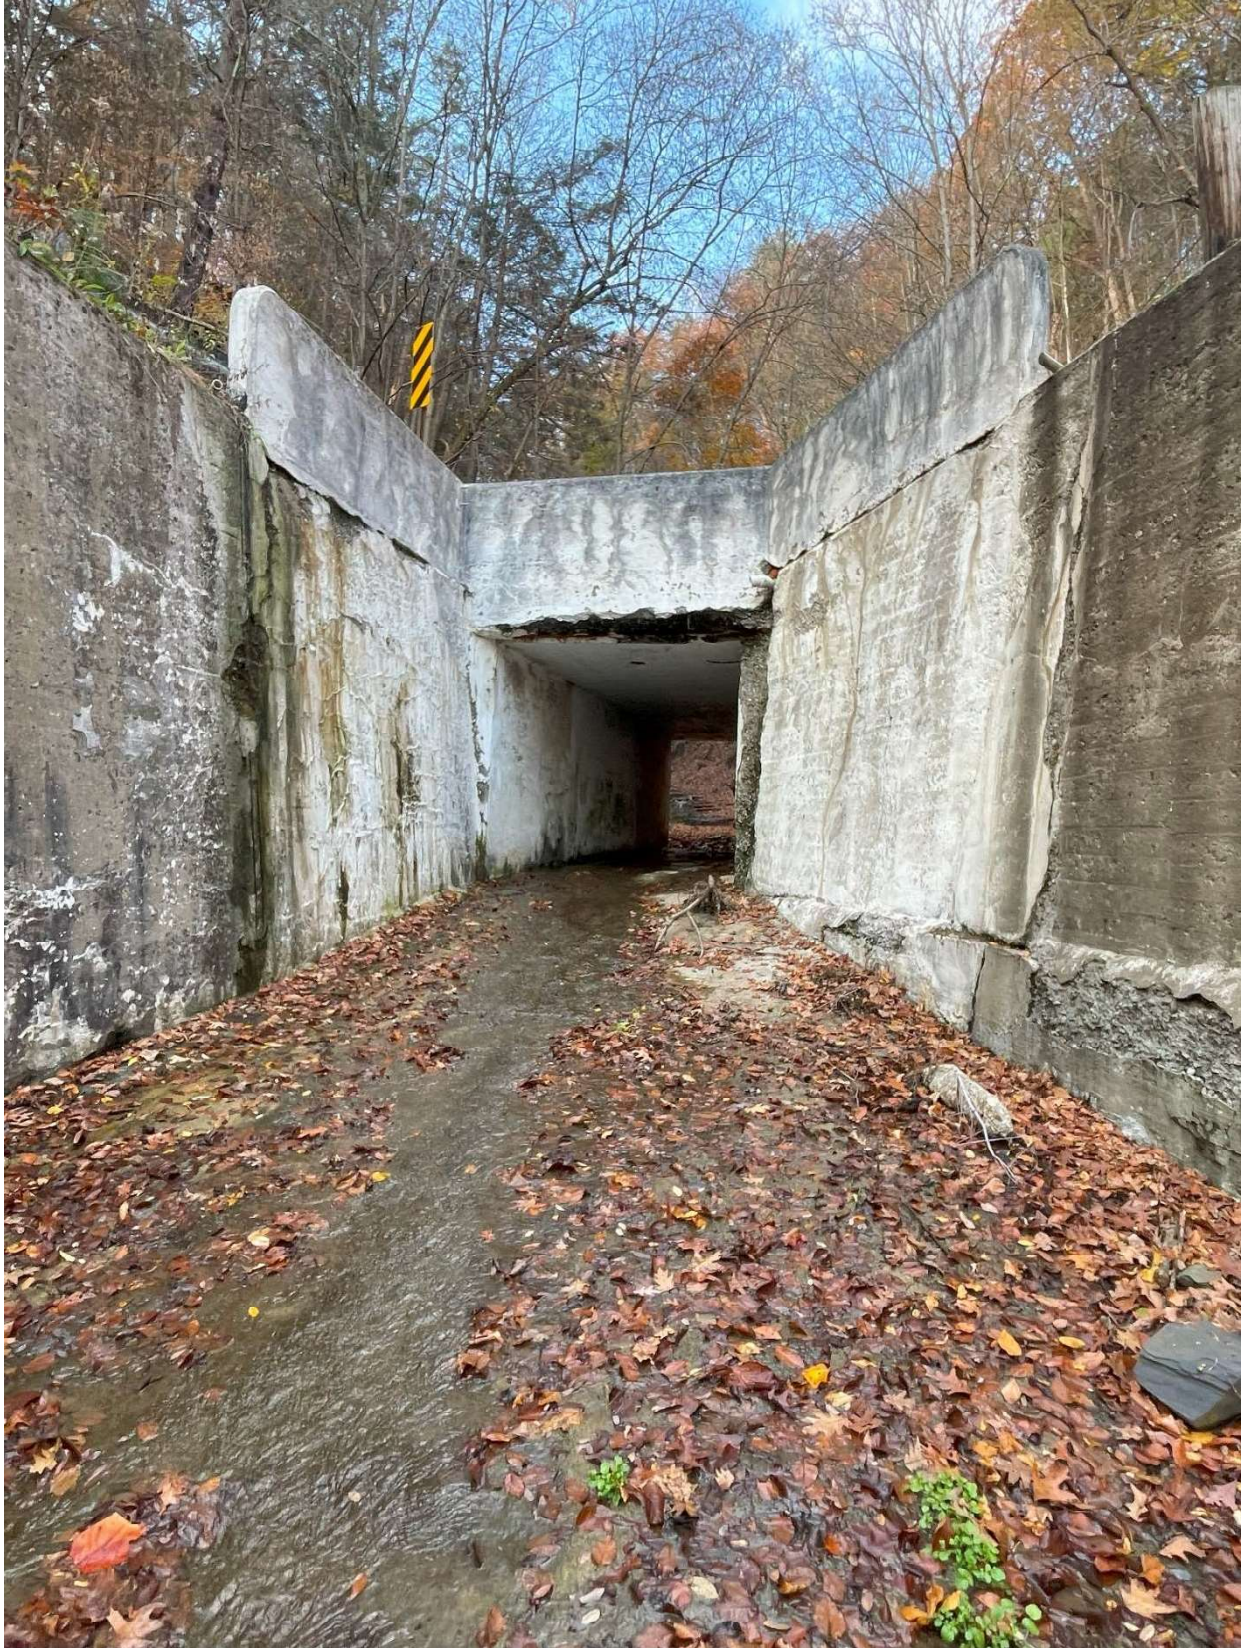
Figure 3. Maplewood Road culvert looking west. Spalling concrete with steel reinforcement exposed and corroding.

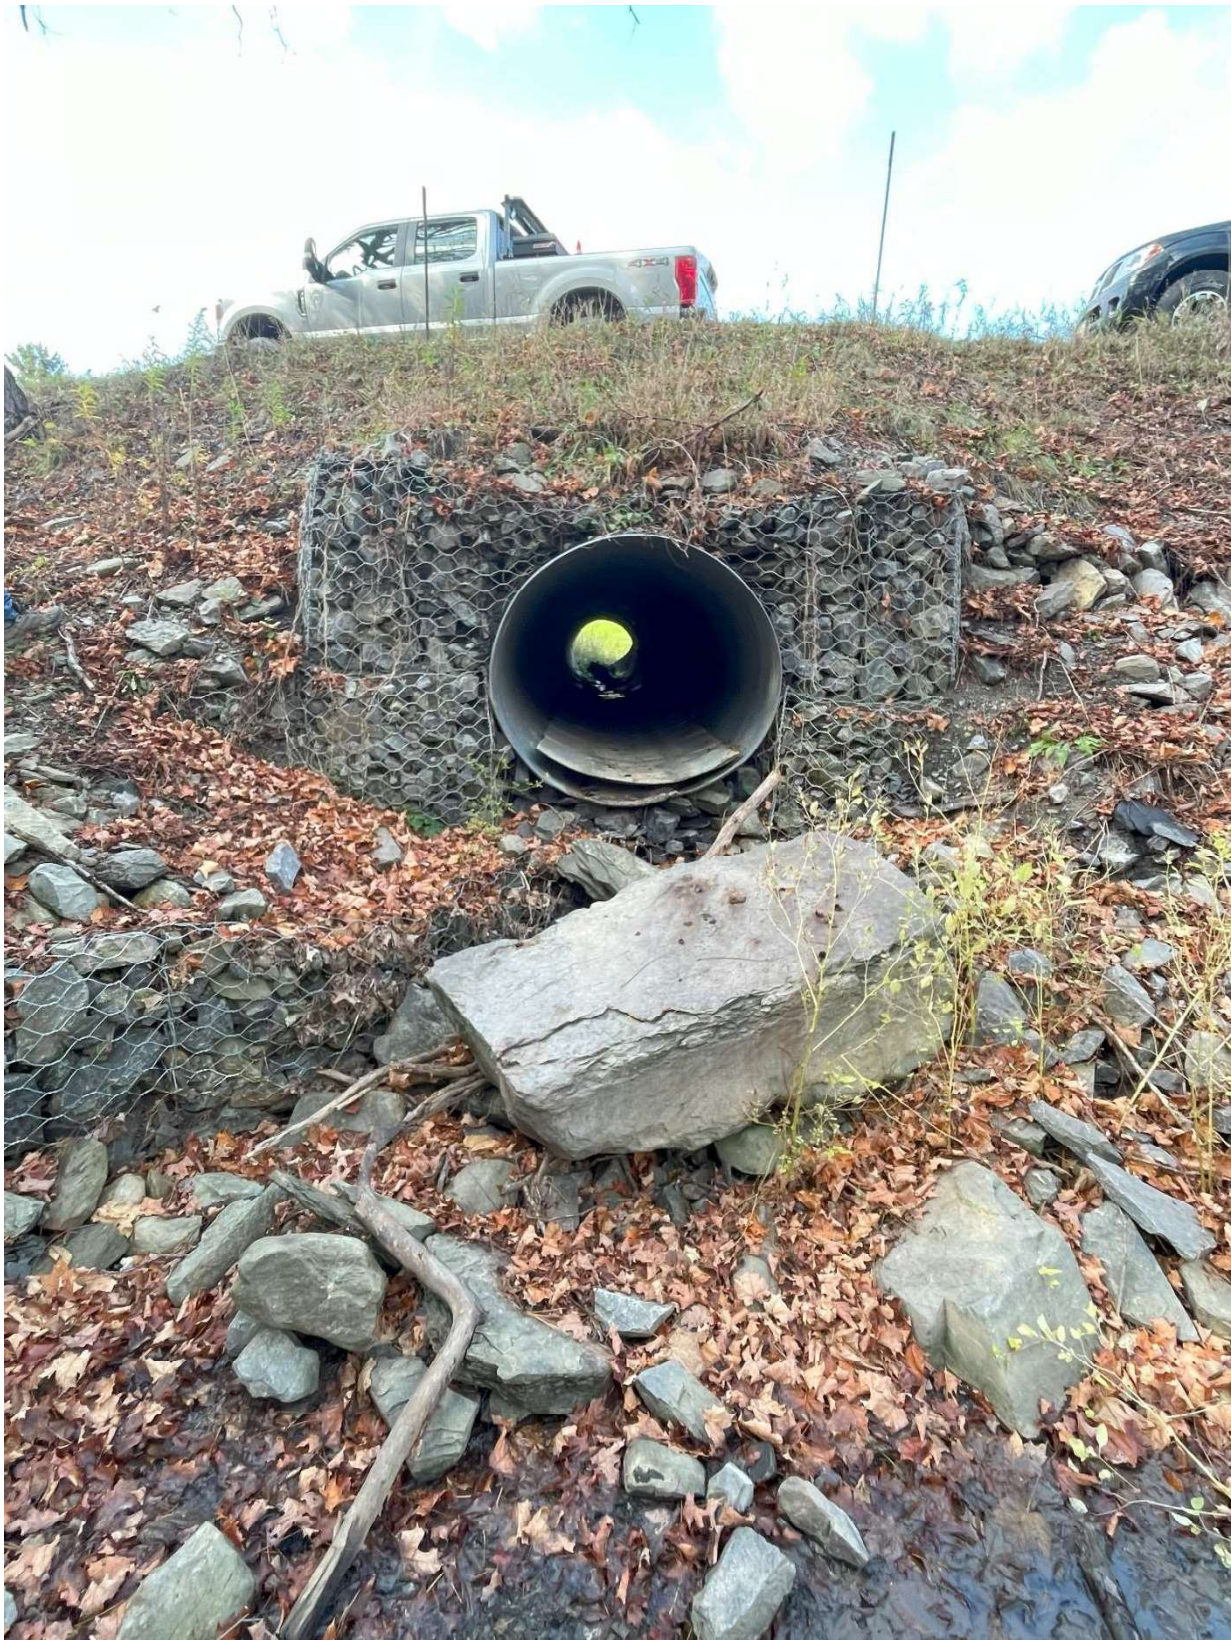
Figure 6. Garrett Road culvert looking west. No embedment throughout the culvert.

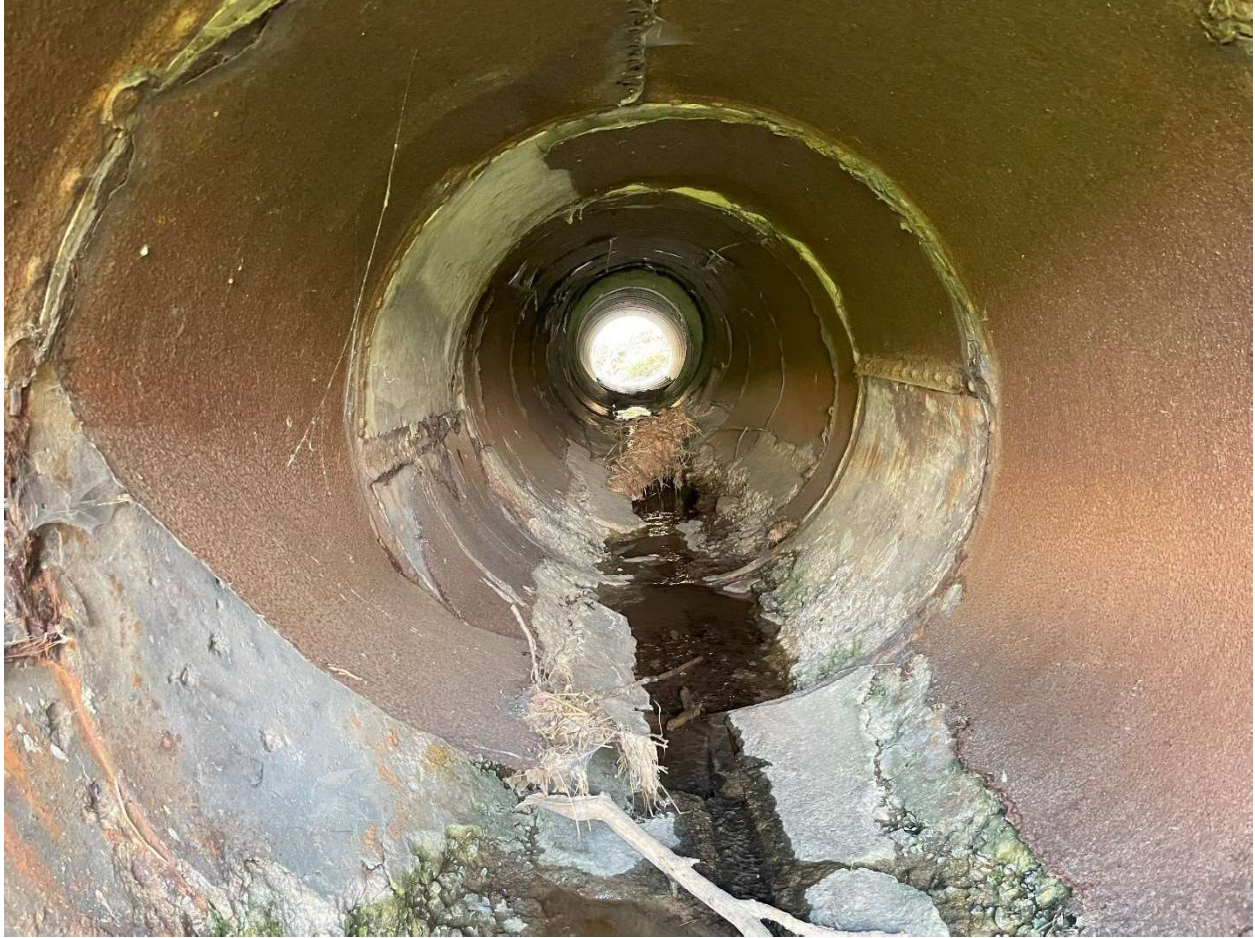
Figure 7. Garrett Road culvert looking west. Large vertical separation between the outlet invert and the streambed below.

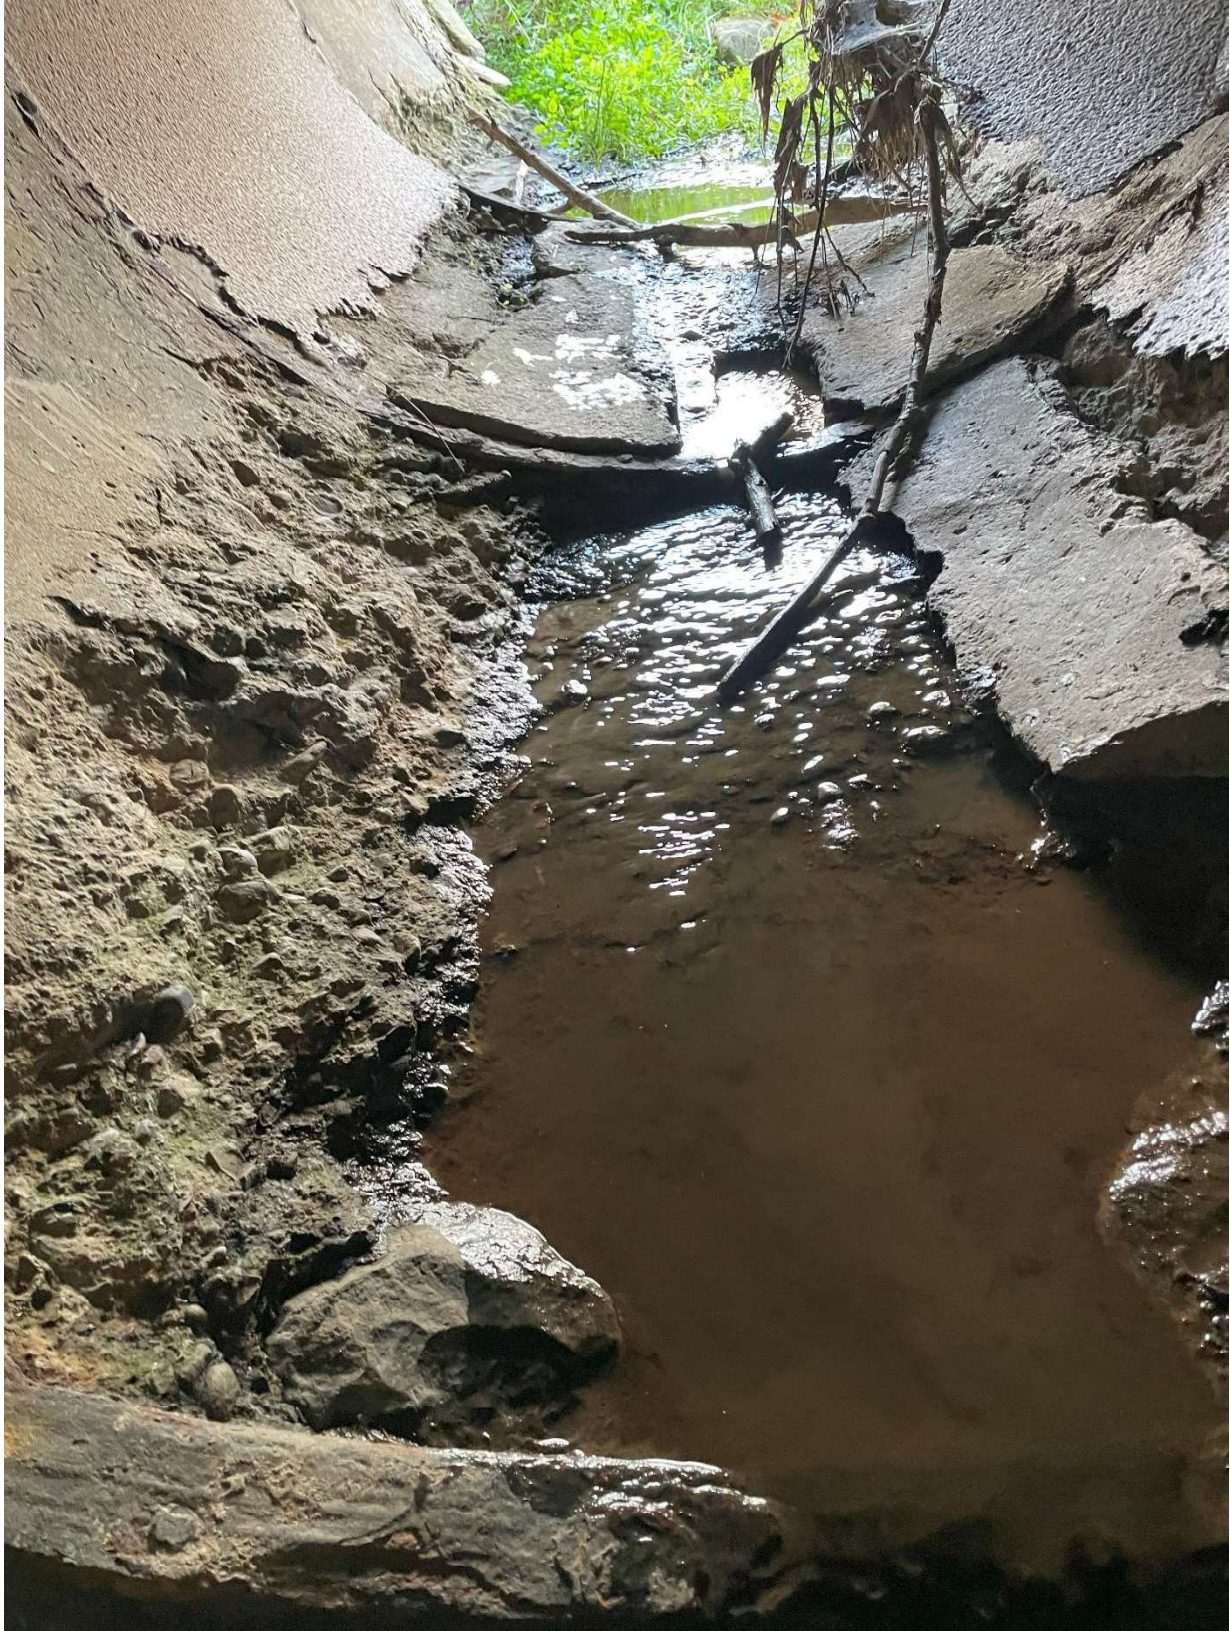
Figure 8. Garrett Road culvert looking east. The metal liner on the inside of the culvert is heavily corroded.

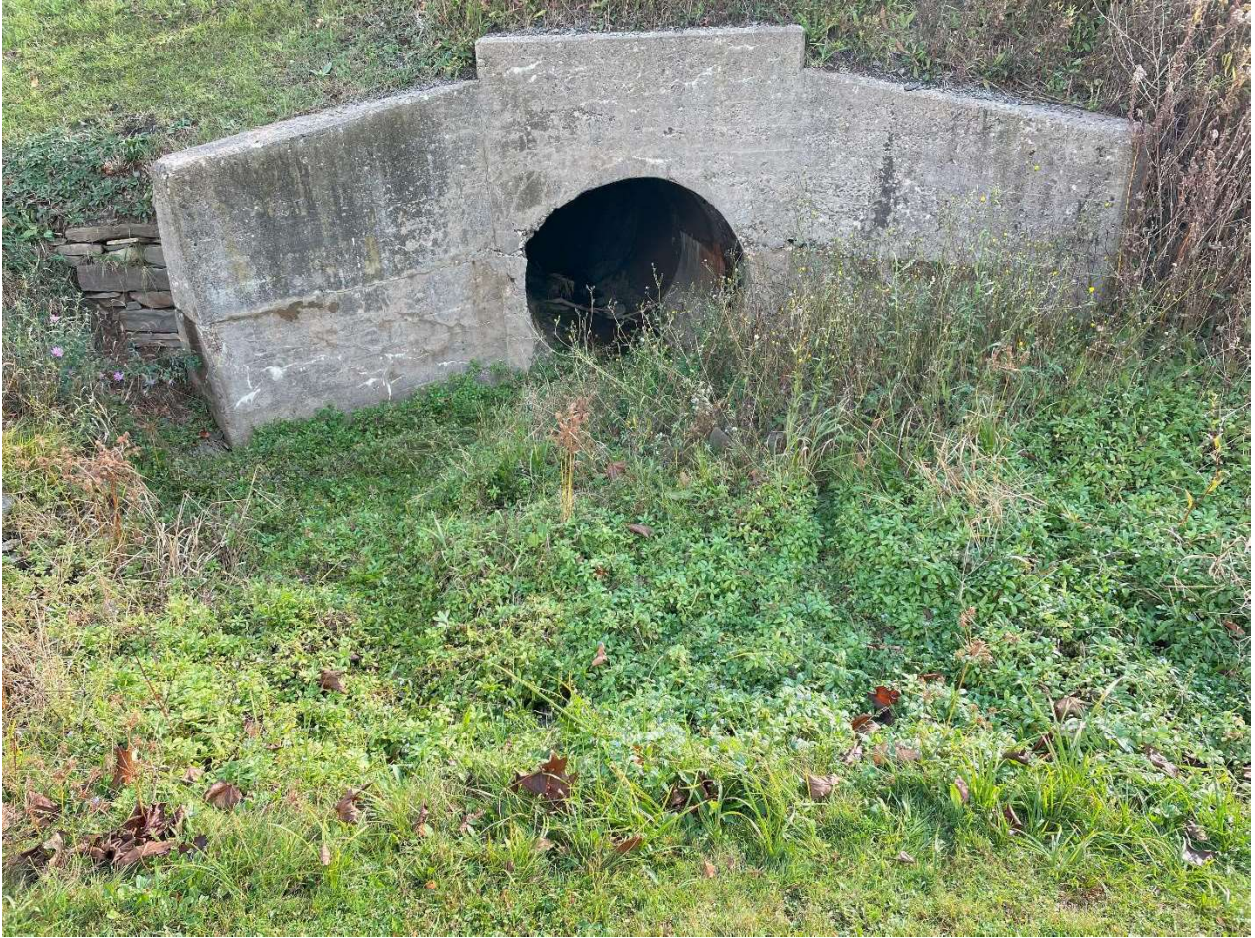
Figure 9. Garrett Road culvert looking west. The concrete on the bottom of the culvert is spalling.

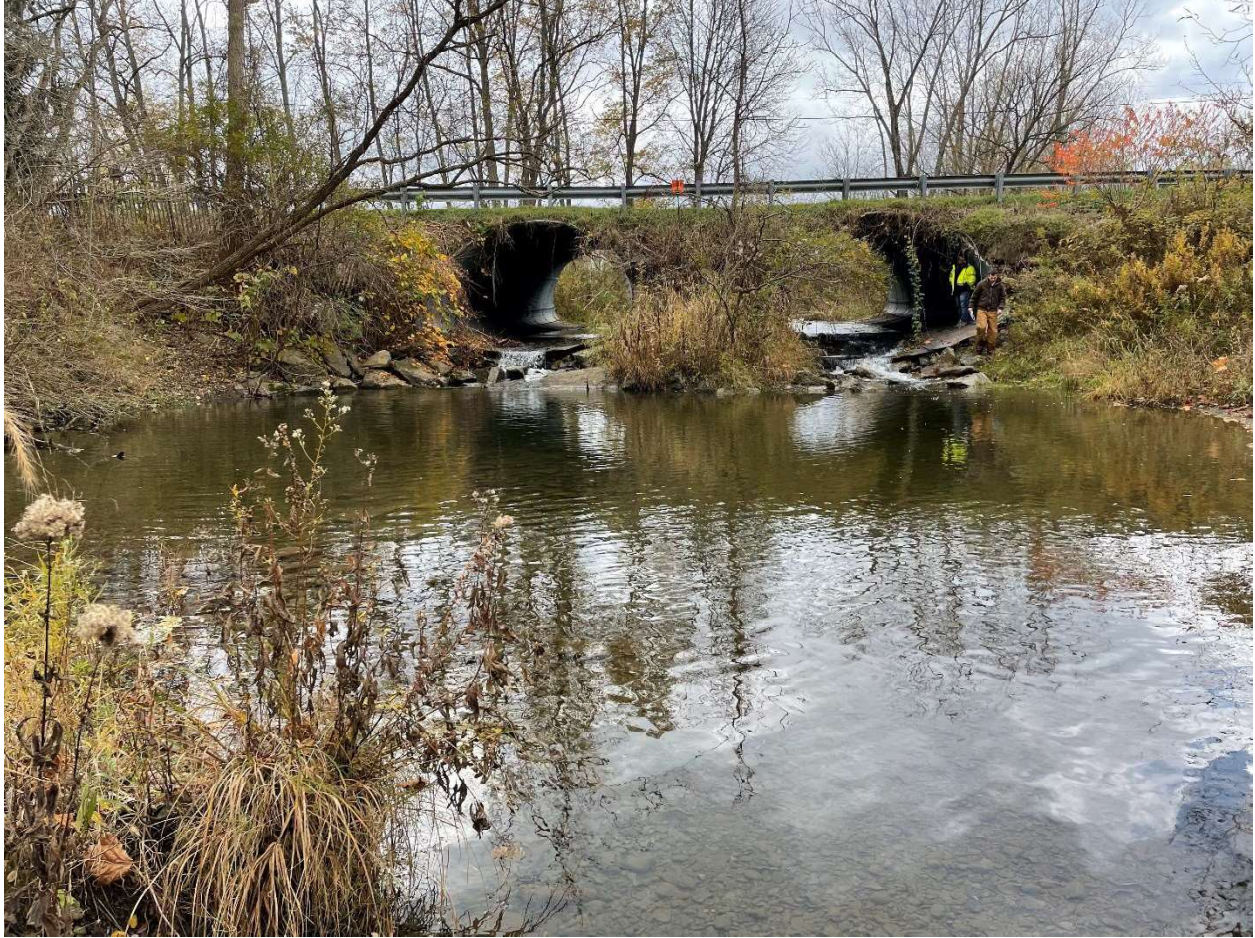
Figure 13. Curry Road west culvert looking north. No embedment throughout the culvert.

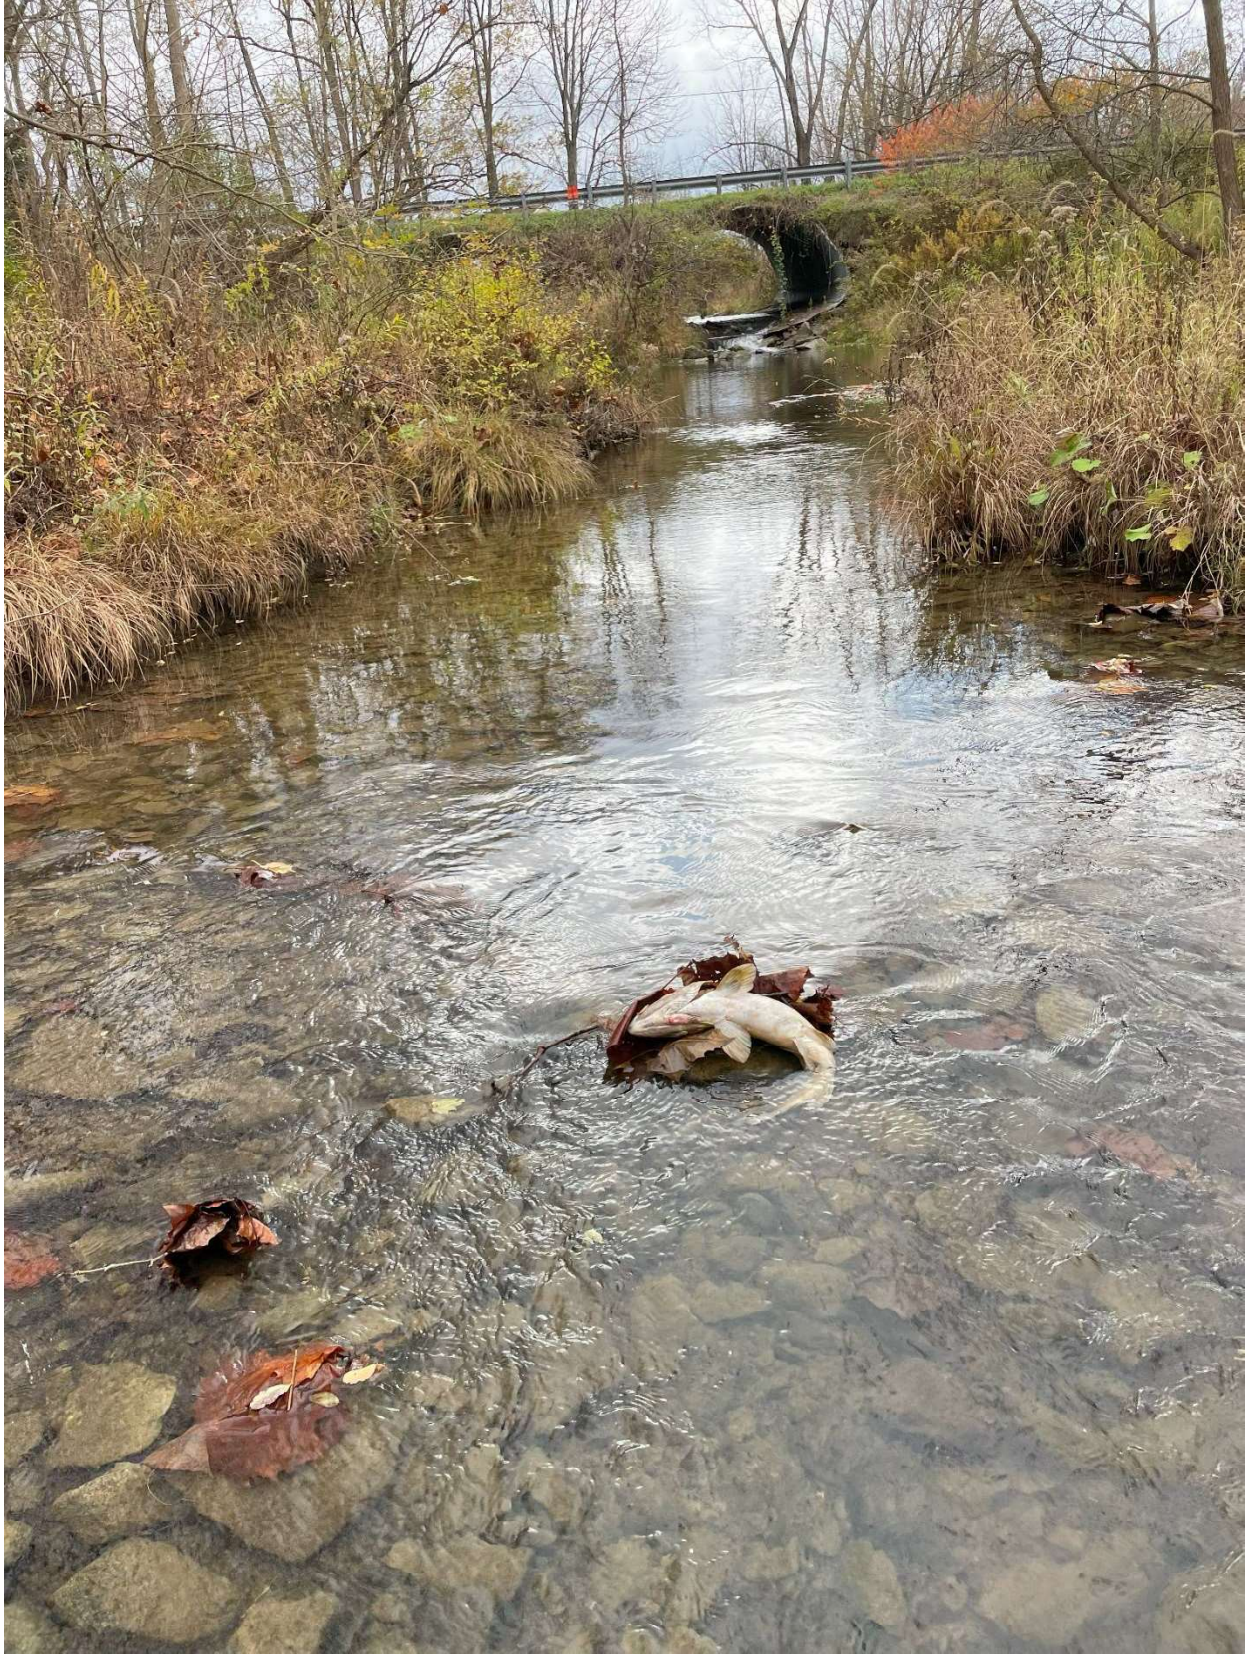
Figure 14. Curry Road culverts looking south. Large vertical separation between the outlet inverts and the streambed below.

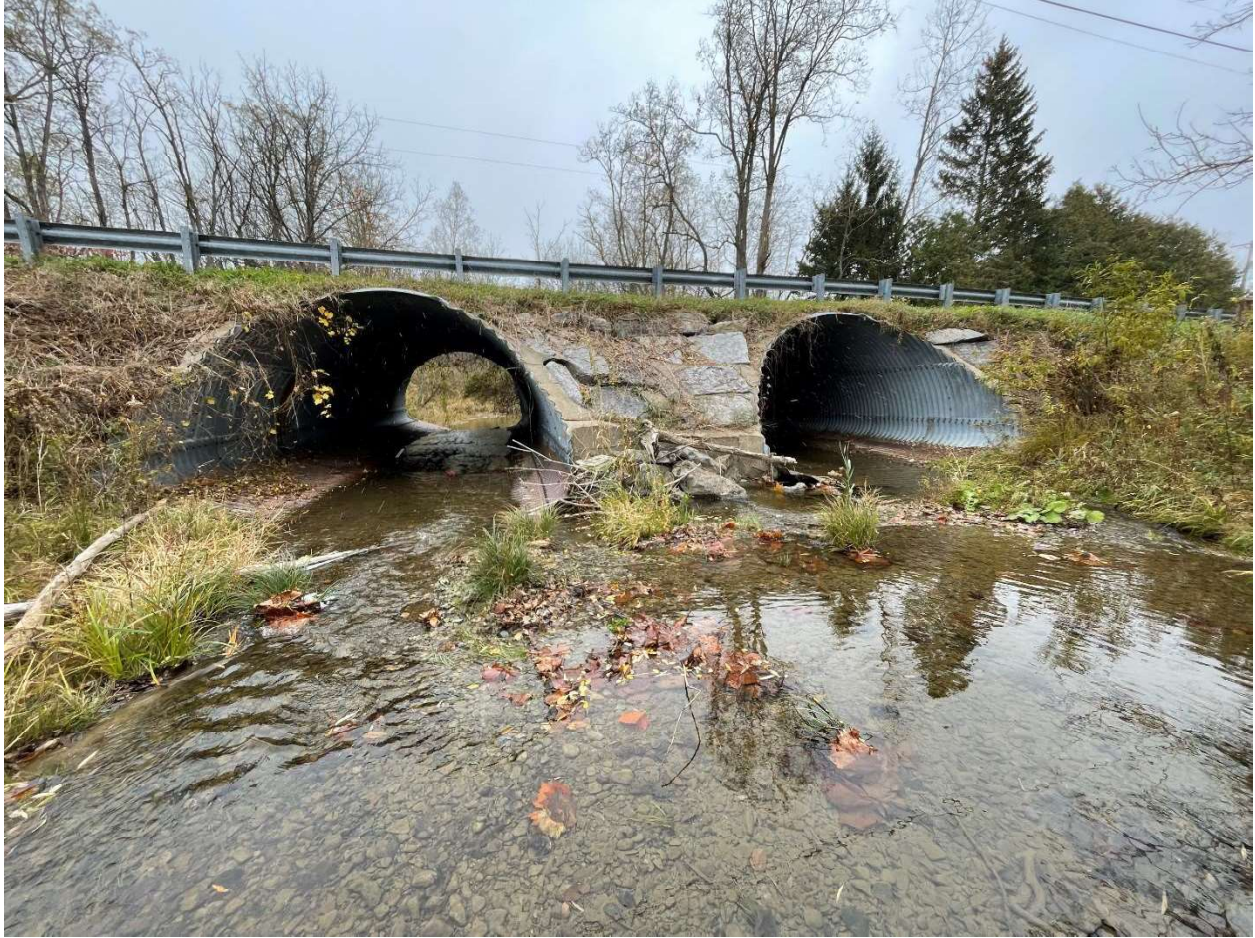
Figure 15. Curry Road east culvert looking south. Dead trout in the stream in the foreground.

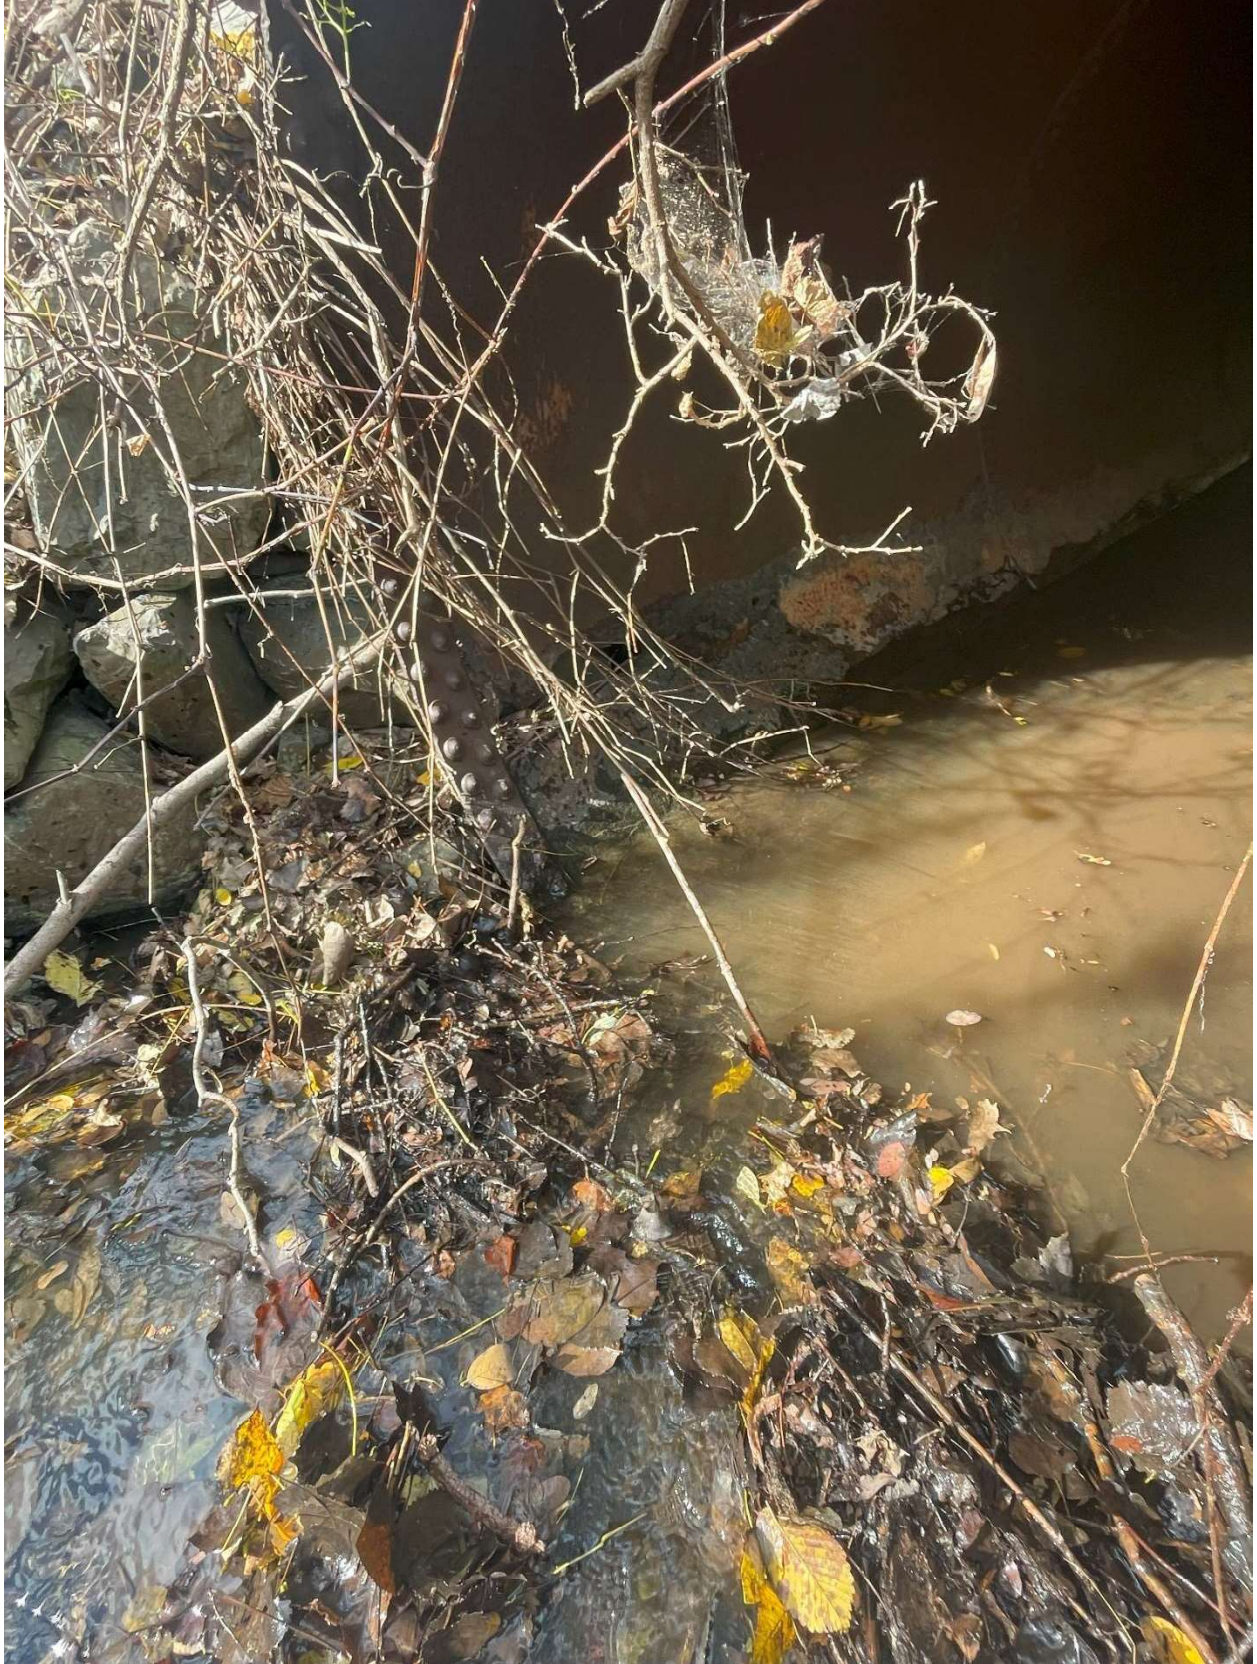
Figure 20. Corrosion on the inside of one of the Reynolds Road culverts.

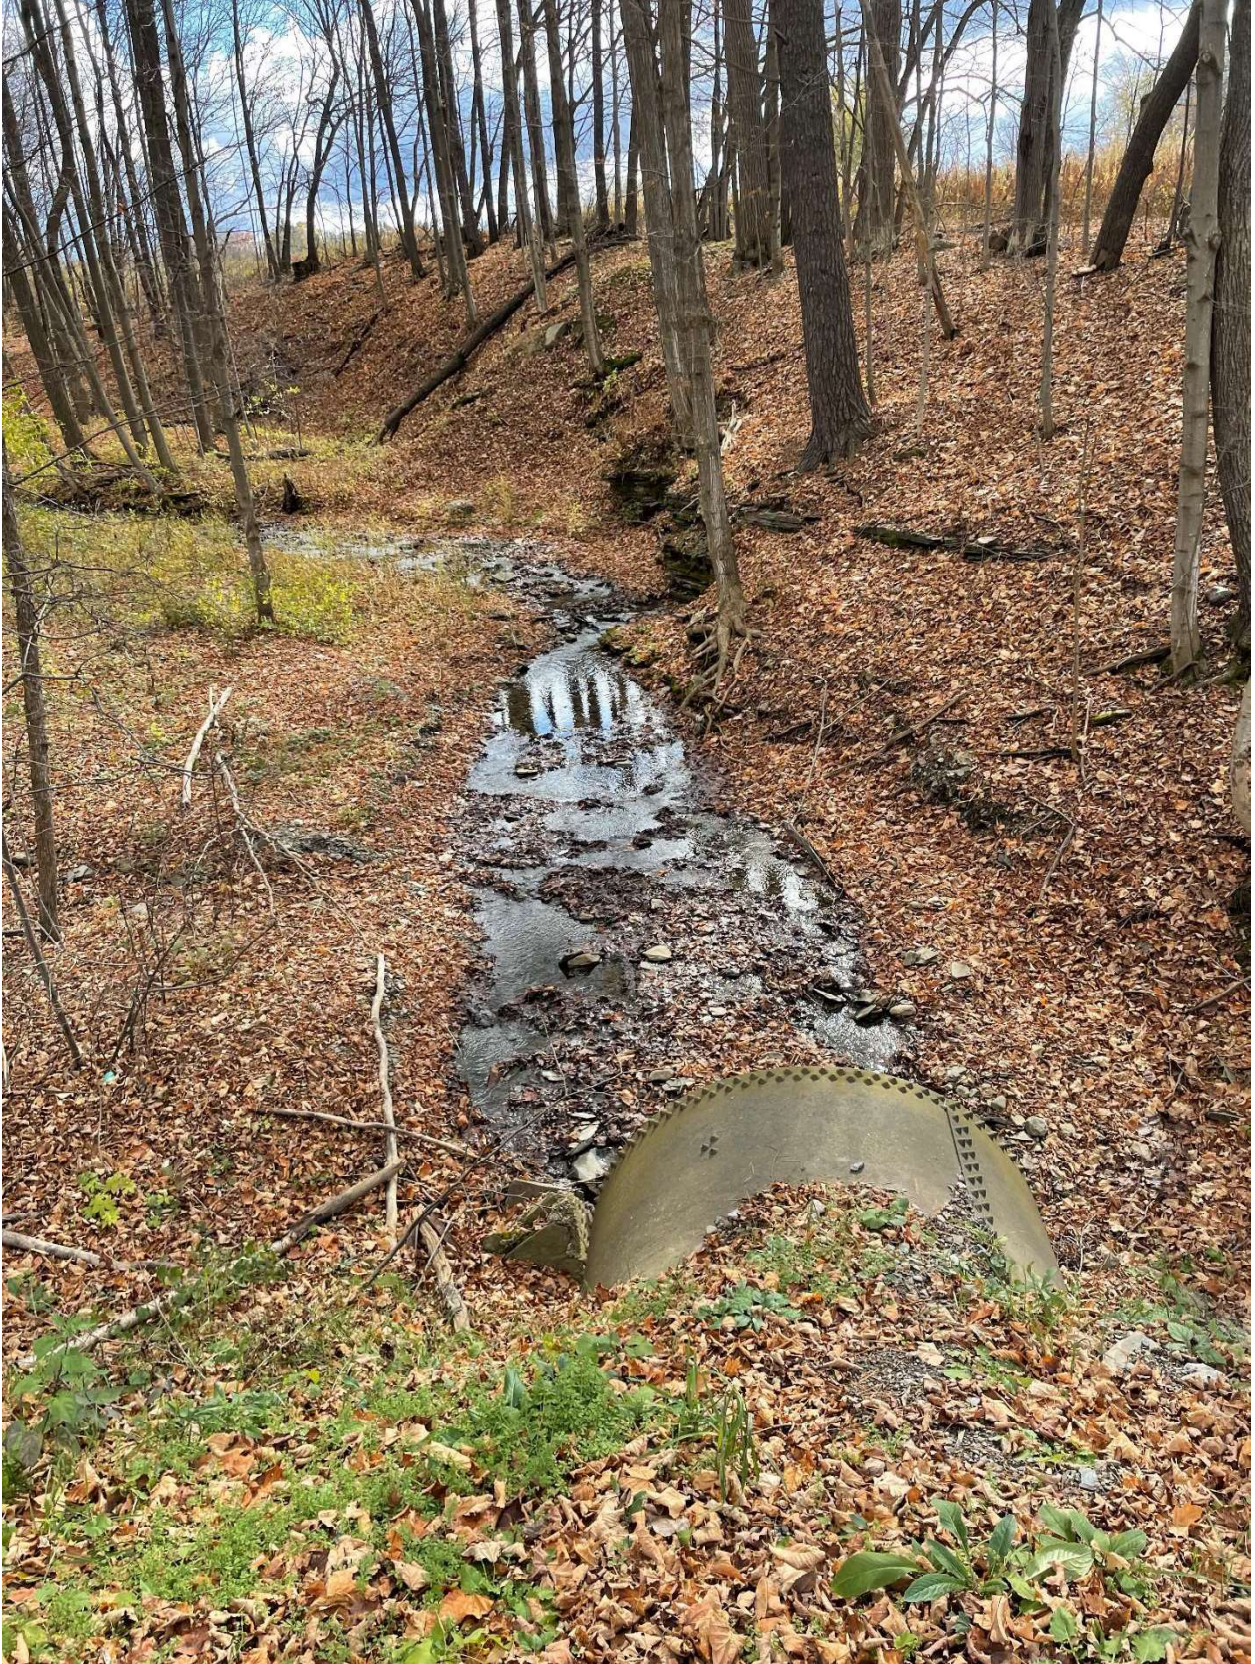
Figure 21. Corrosion on the inside of one of the Reynolds Road culverts.

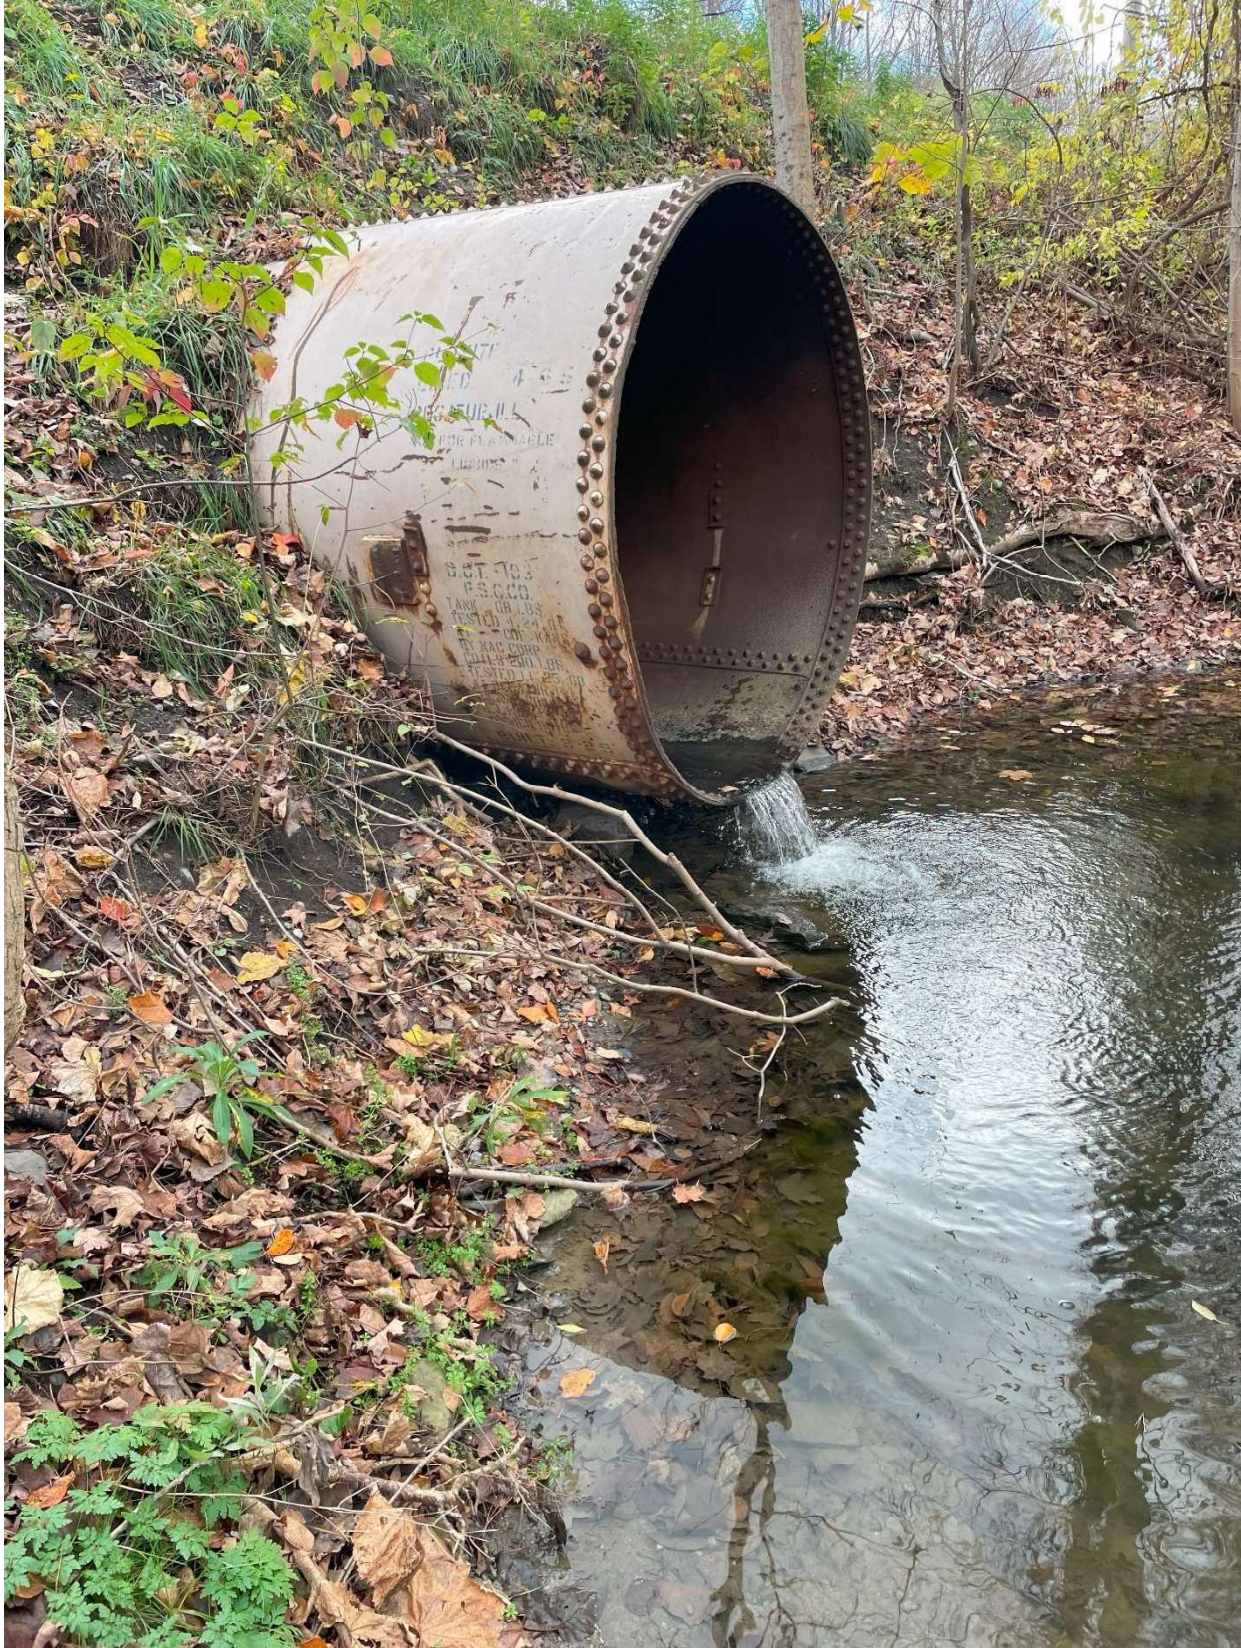
Figure 25. Iradell Road culvert. The rivets on the inside of the culvert are corroded and falling apart.

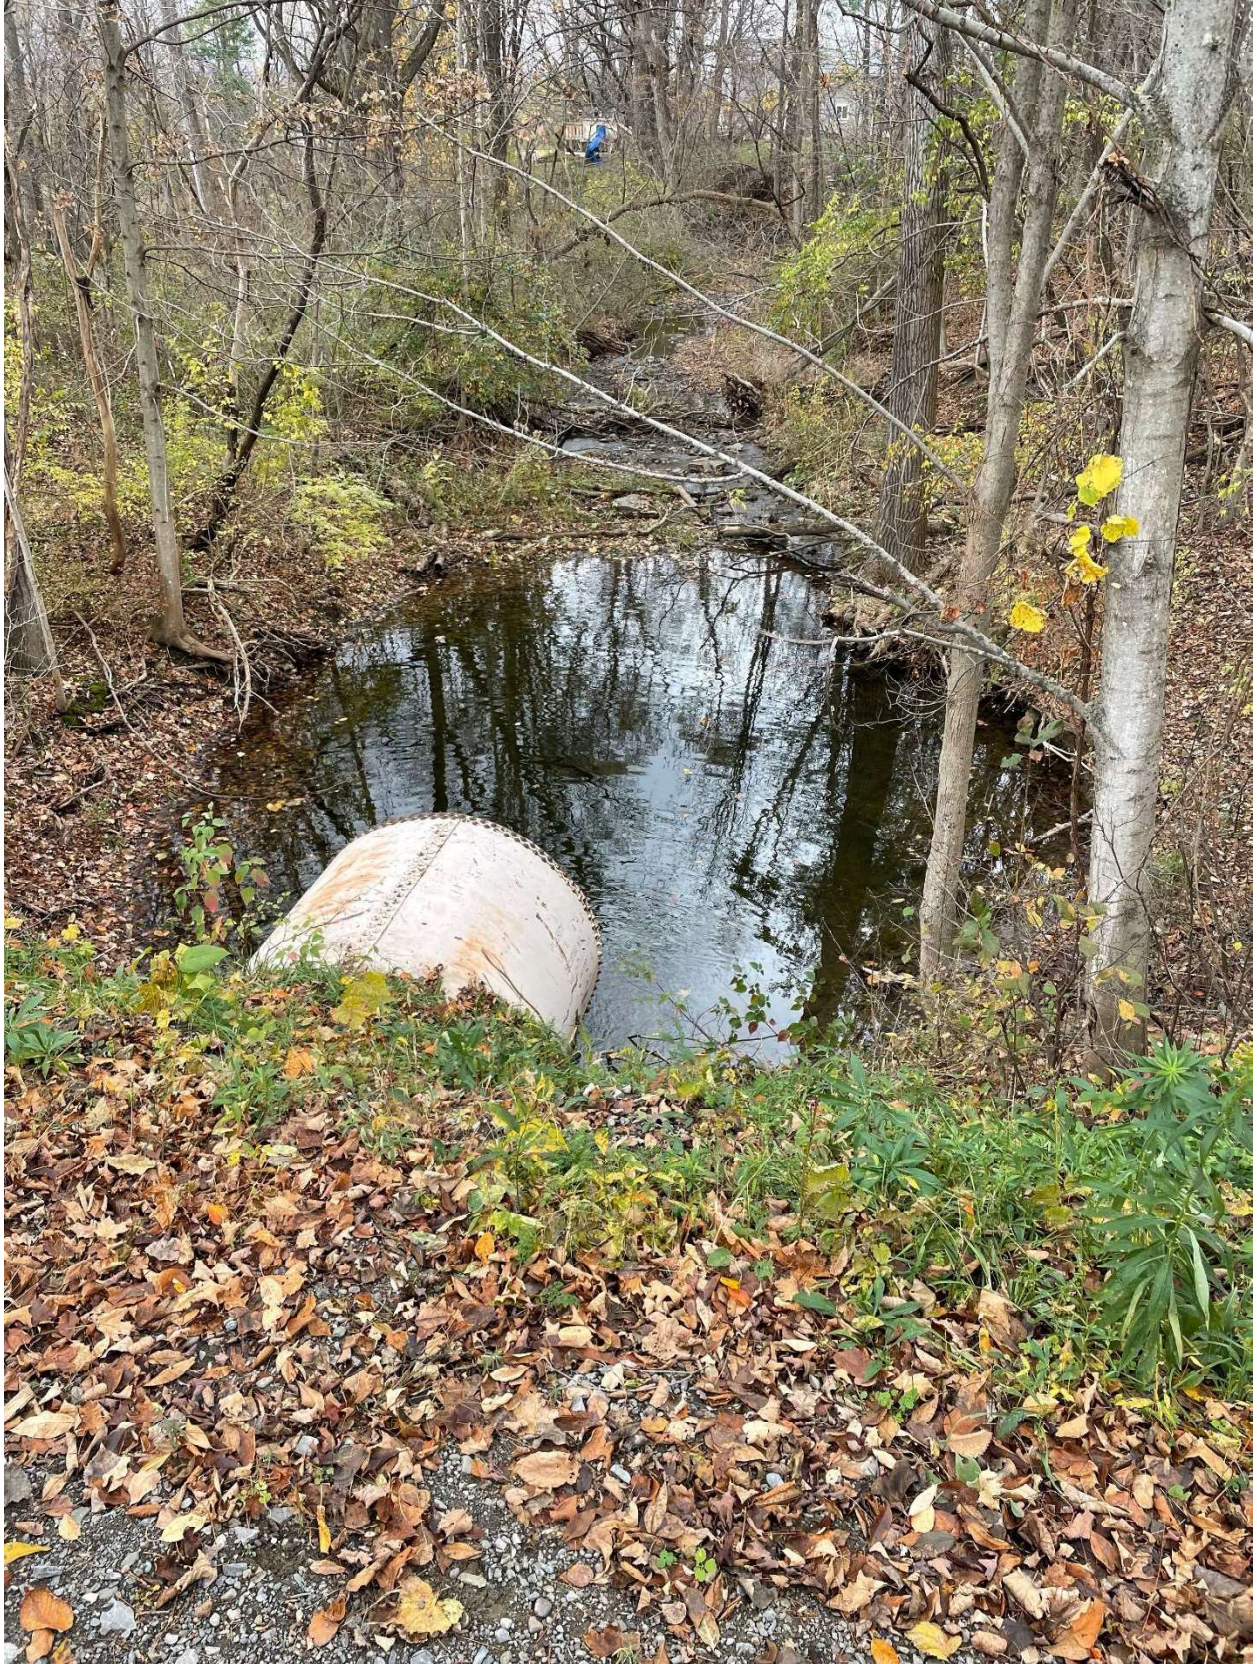
Figure 28. Iradell Road culvert looking south. There is a large pool forming at the outlet side of the culvert.

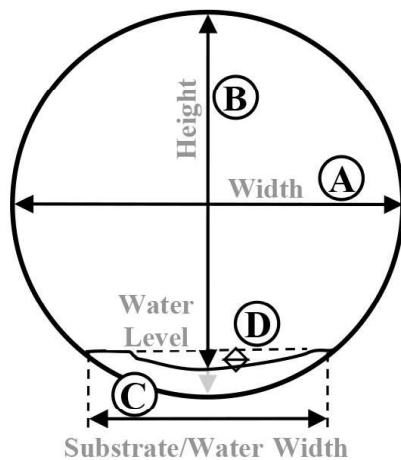
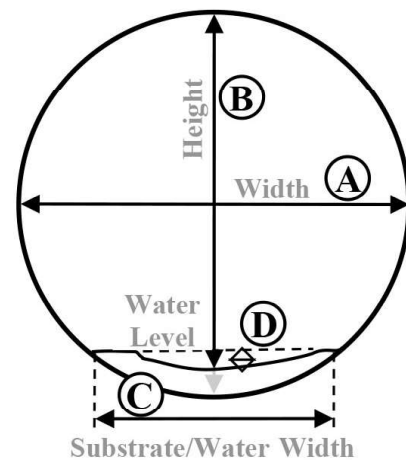
Structure Comments: 2/3 way through becomes corrugated metal. Rusting out through the bottom of the entire structure, the inlet portion of structure has sheets of metal peeling off.
