Curry Road Proposed Culvert - 100 Year Storm

Reynolds Road Existing Culvert - 100 Year Storm

APPENDIX E

EXISTING CULVERT PHOTOGRAPHS

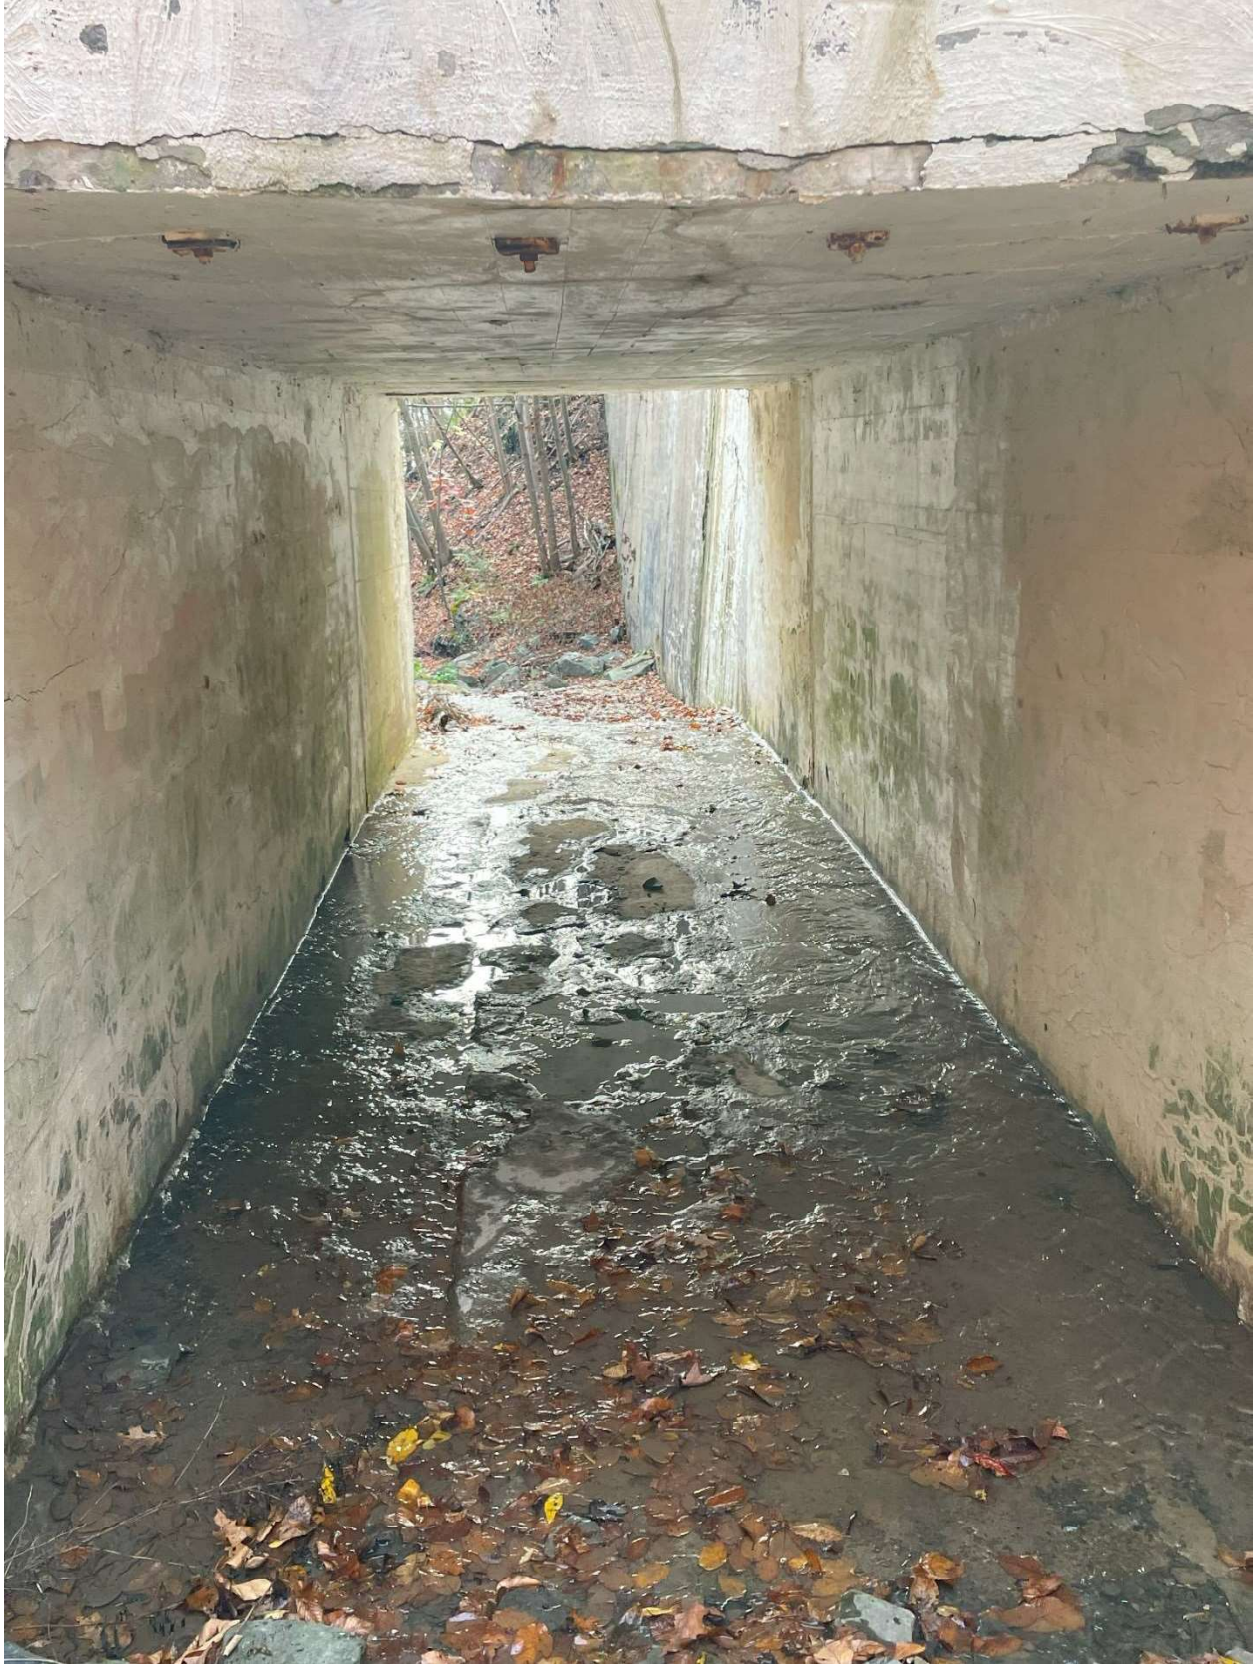
Figure 1. Maplewood Road culvert looking east. No embedment throughout the culvert.

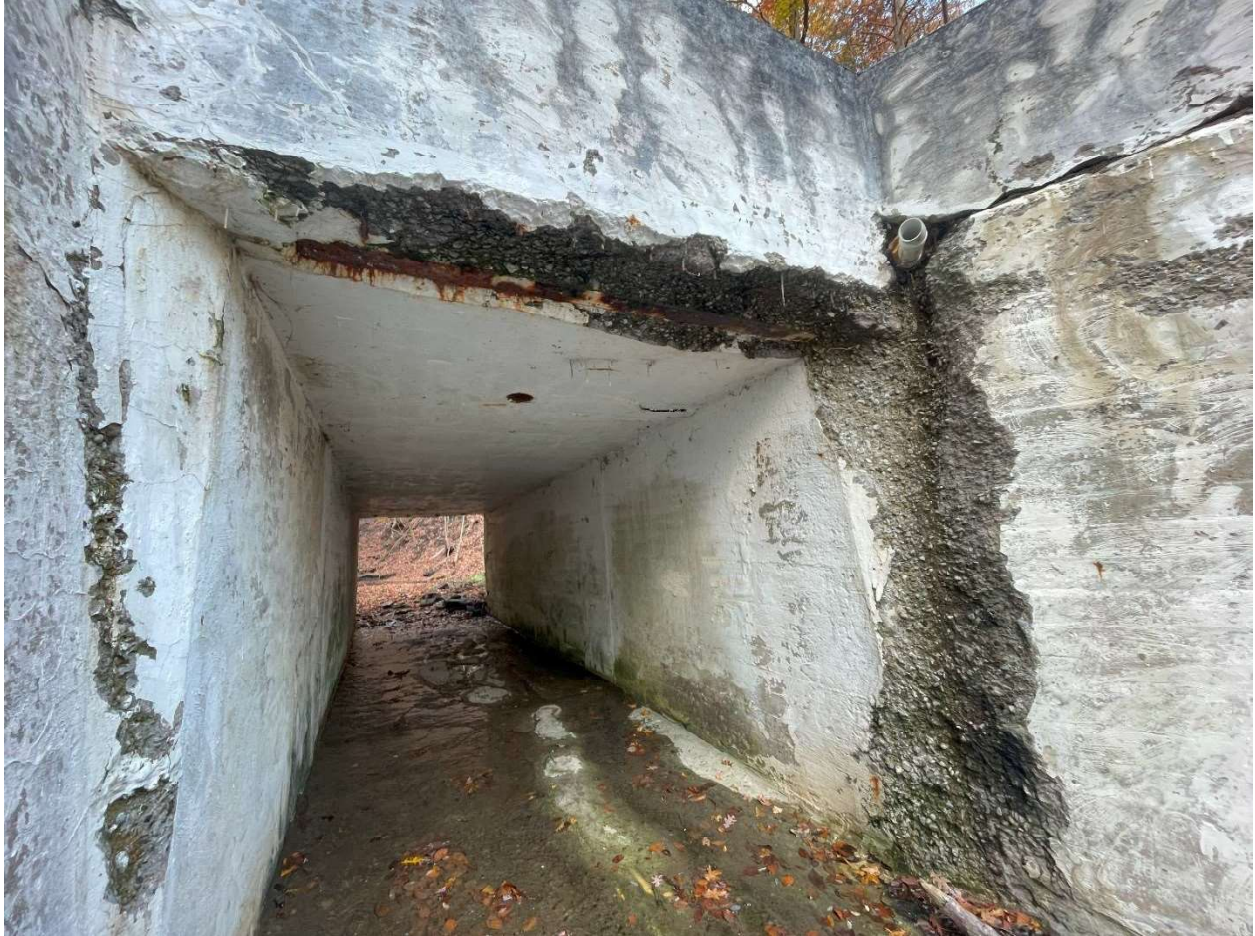
Figure 3. Maplewood Road culvert looking west. Spalling concrete with steel reinforcement exposed and corroding.

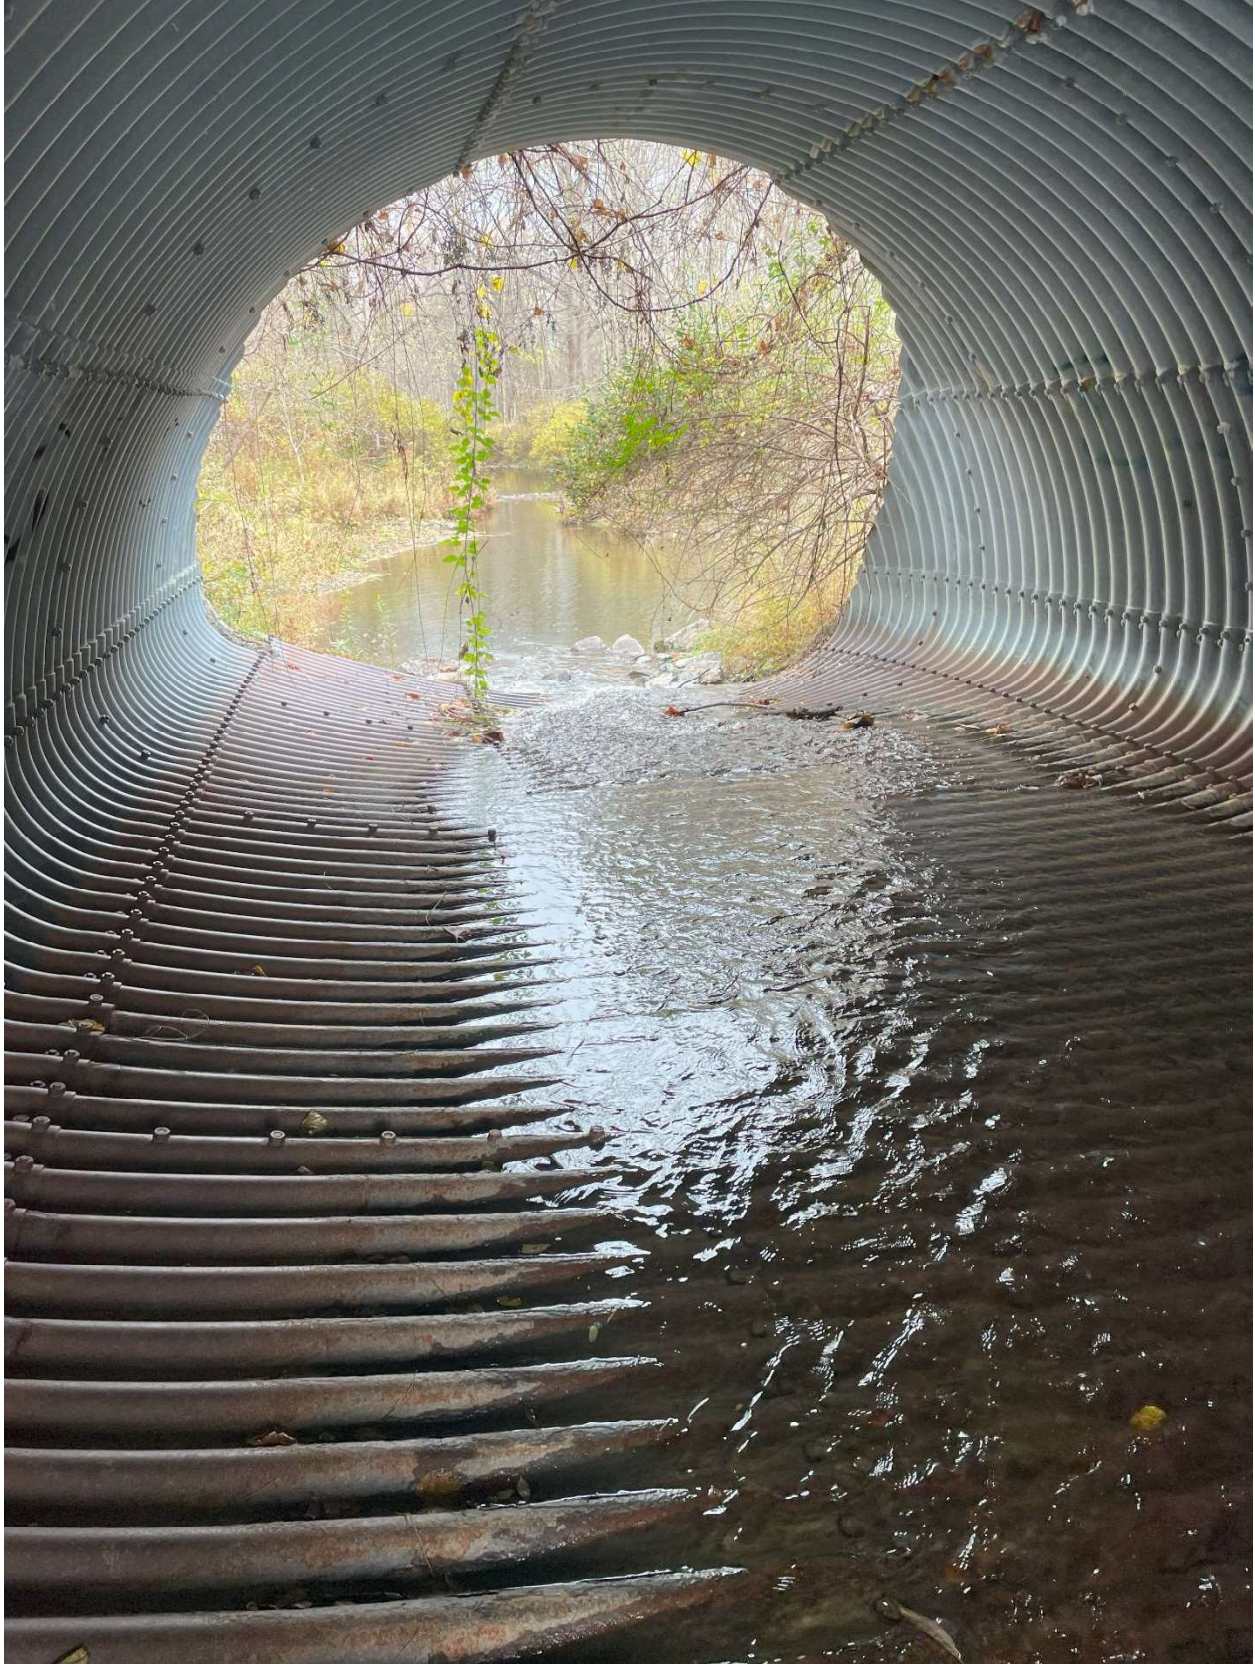
Figure 13. Curry Road west culvert looking north. No embedment throughout the culvert.
